**Researchers explain artificial slate
and shale products' spotty history**

by Stephen J. Condren, PE,
and Werner H. Gumpertz, PE

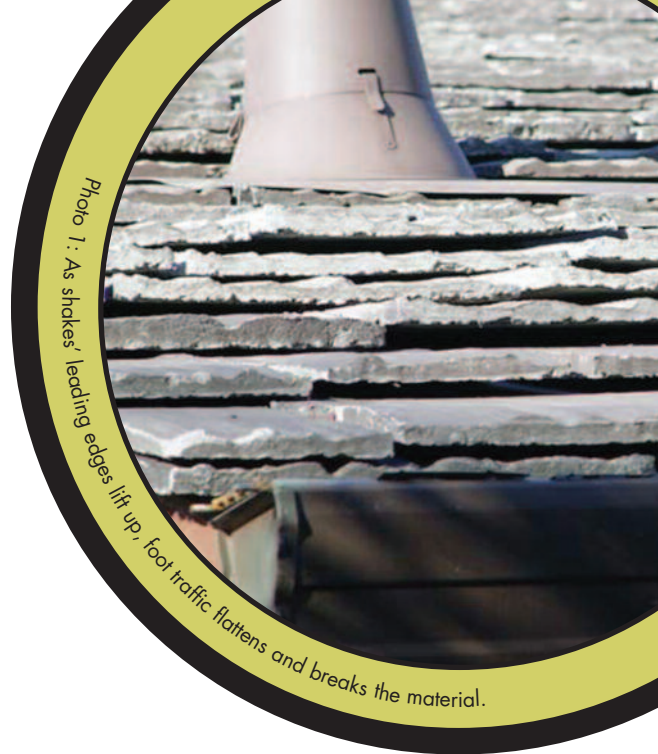
Photo 1: As shakes' leading edges lift up, foot traffic flattens and breaks the material.

The 4.2-pound handleability index shows the products are more friable than natural slate. Product 2 had a warp or cupping (see Photo 1) of $\frac{3}{4}$ of an inch that is flattened by a modest 24-pound load on the front edge. Water absorption of 24 to 25 percent is consistent with many other fiber-cement shingles and shakes.

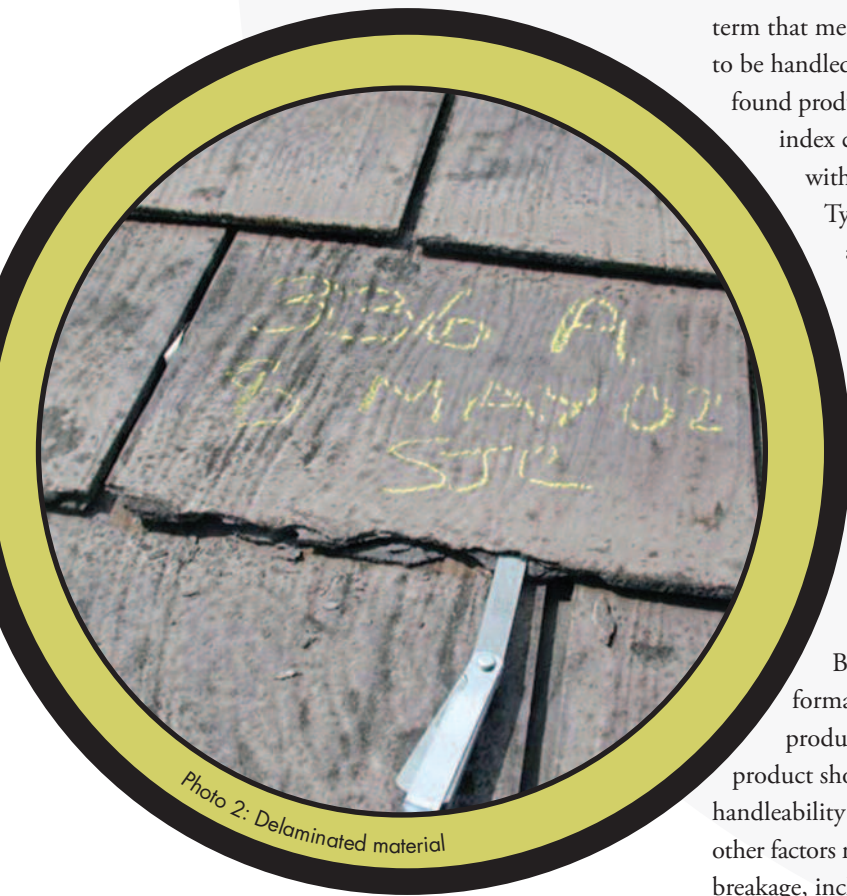
Photo 2: Delaminated material

similar to the equipment used to make asbestos-cement sheets and shingles where the thickness was made of relatively thin sheets laminated together. Product 5 curled and became embrittled—probably because of carbonation of the free alkalis present—and frequently delaminated after weathering (see Photo 2). Walking on the roof broke the shakes (see Photo 3).

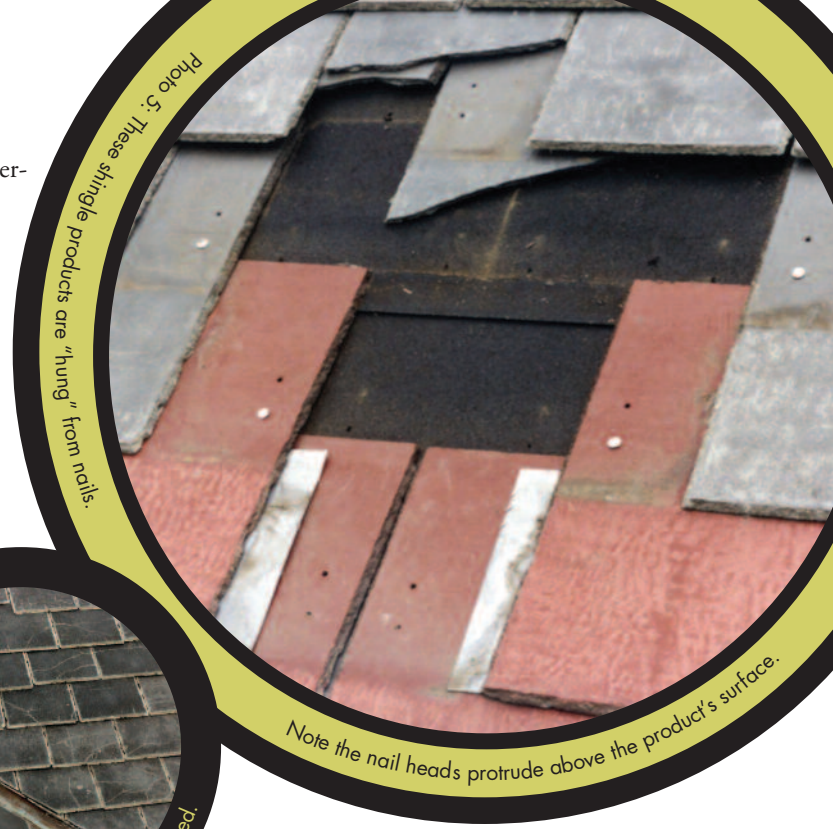
Photo 5: These shingle products are “hung” from nails.

Note the nail heads protrude above the product’s surface.

The first public report of this product's poor performance was in 1995. We found cracked and broken slates during our many field investigations (see Photo 4). These slates were designed to be hung (see Photo 5) on incompletely driven nails (as are natural slates) in plywood decks. A high percentage of the cracks in the slates were over the nail heads (see Photo 6) of the shakes. Blotchy color variation marred some roofs.

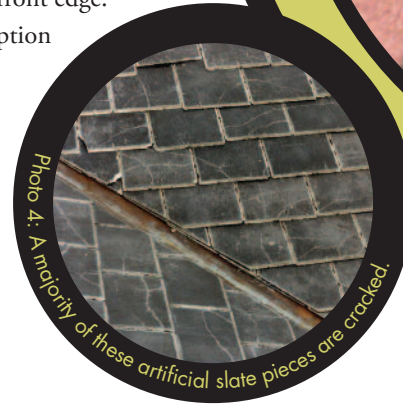
Photo 4: A majority of these artificial slate pieces are cracked.

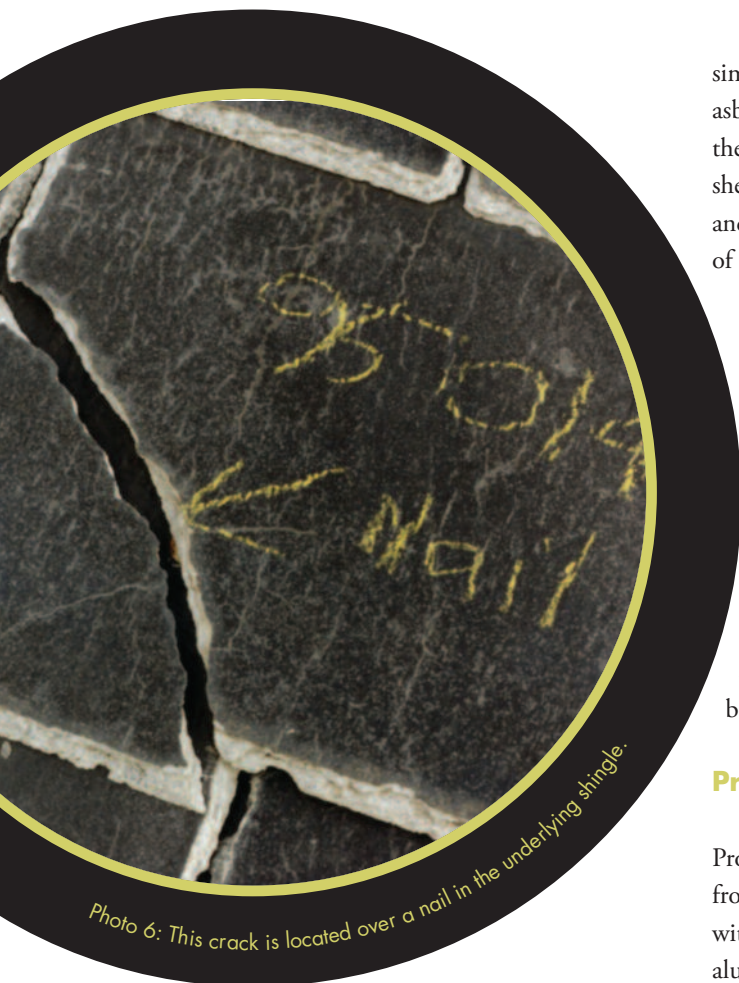
Photo 6: This crack is located over a nail in the underlying shingle.

less than the thickness of the nail heads typically used to install these products, explaining the high frequency of cracks in the product over the nail heads.
